TECHNICAL PROGRESS REPORT 381 NOTS TP 3674 COPY 1

624A SOLID-PROPELLANT MOTOR IMPACT TEST

U.S. NAVAL ORDNANCE TEST STATION

October 1964

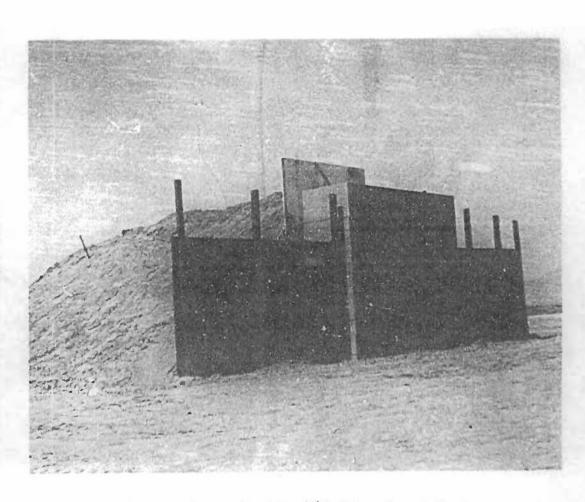
FIG. 1. Target Used in 624A Motor Impact Test.

The target face was constructed of reinforced concrete 6 ft in depth with a 20 x 20-ft impact surface. The concrete face was backed with 3-in. steel plate and this, in turn, was backed with approximately 35 ft of earth fill, 20 ft high. The concrete was prefabricated in blocks and placed in position 100 ft off the muzzle end of the track. The target impact surface had openings to accept the sled trucks to insure that the test item experienced initial contact. Figure 1 is a view of the target before the test.

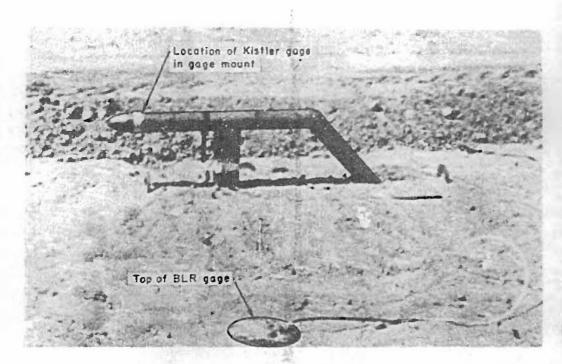
FIG. 2. Enlarged Film Frame Showing Typical Blast Gage Installation.

Overpressure Gages. Overpressure was measured with Kistler piezoelectric and Ballistics Research Laboratory (BRL) gages. The Kistler
gages use remotely controlled Ampex FRIOO tape recorders to collect data;
the BRL gages have a self-contained recording device. The pressure is
sensed on a diaphragm that is attached to a stylus. The stylus scribes
the diaphragm movements on an aluminum-coated glass disc. The disc is
retated by a chronometrically governed DC drive motor. Diaphragus rated
to measure anticipated overpressures were placed in the gages. Figure 2
shows a typical gage installation. Both types of gages were mounted to
get side-on, pressure-time data. The Kistler transducer was mounted at
the top of the horizontal section of tubing shown in the photograph. The
BRL gages were mounted flush with the ground surface.

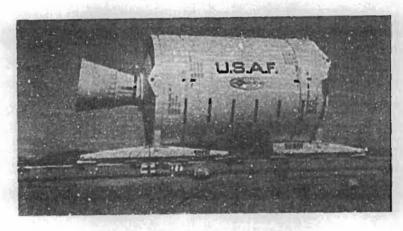
FIG. 7. Motor Ready for Firing.

The day before the test, the telemetry package was installed and checked out; the destruct receiver and decoder were mounted on the motor, and the motor was prepared for firing with the exception of installing the initiator and destruct charges. Instrumentation checkouts were in progress during the week. Figure 7 shows the motor ready to be fired.

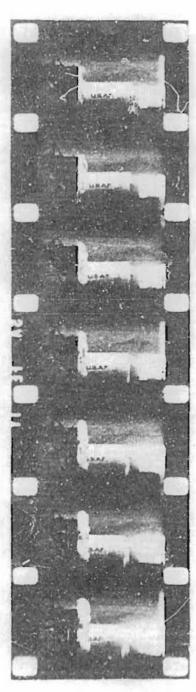
FIG. 8. Enlarged Sequential Film Frames Showing Motor Impact.

Surveillance film shows that the motor penetrated approximately six ft into the target before failures were apparent. The case expanded and cracked at the forward end of the motor in both quadrants on the west side. The cracks propagated to the aft end of the segment as the motor tried to penetrate deeper. The first sign of fire came from the front of the motor after target penetration. After the motor had entered the target to approximately half the motor length, the aft closure ruptured around the nozzle followed by complete destruction of the motor. Figure 8 shows enlarged lemm film sequence of motor impact. The force of the explosion left a crater approximately seven ft deep where the target had been.

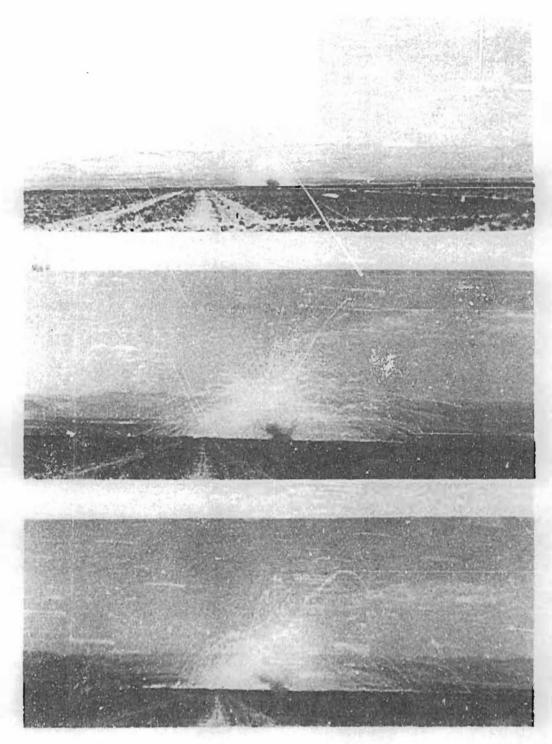
FIG. 9. Photographic Sequence After Motor Impact as Viewed From a Distance of 4.1 Miles. Sequence is from top to bottom.

Figure 9 is a series of pictures of the propellant after it was expelled from the motor (burning propellant was thrown as far as 3,000 ft from the impact point). Figure 10 is a sample of the size of the pieces of unburned propellant, most of which was found along the track. The total amount of unburned propellant was quite small. Residue on the ground surface left by the impact of the burning propellant was roughly circular in shape and varied from two inches to ten feet in diameter. The sand was melted and the residue had the appearance of aluminum.

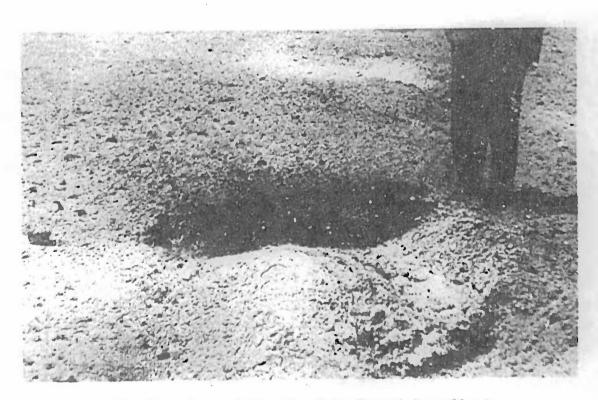
FIG. 11. Typical Residue From Burned Propellant.

Figure 11 shows typical residue from burned propellant. The forward closure (Fig. 12) was found 270 ft beyond the target site. Figures 13, 14, and 15 show the debris to the east, west, and north of the target location; Fig. 16 shows the nozzle and other debris in the crater; Figure 17 shows the target face from the track muzzle before and after the test. Travel of some fragments was found as shown in Fig. 18. Descriptions of the fragments are keyed to the numbers in the graph. Figure 19 is a montage showing large pieces of debris found between 1,260 and 2,500 ft from point of impact (see note, page 4).

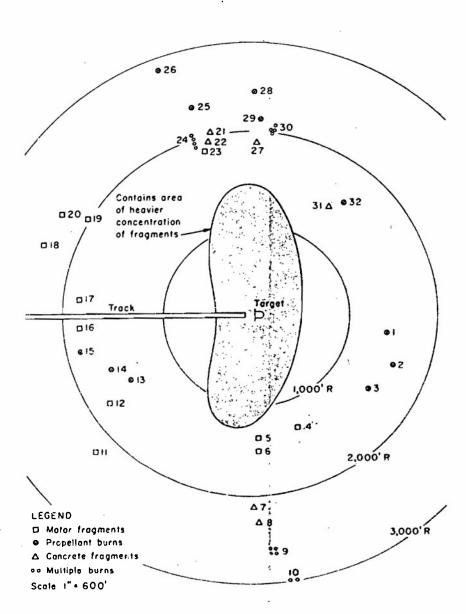
FIG. 18. Dispersion of Fragments

Amber .	Description
1	Residue of burned propellant
5	Residue of burned propellant
3	Reaidue of burned propellant
4	Prognent of rear motor closure, approx. 7'x3'
5	Fragment of sled ring, approx. 5.5' long
6	Prognent of notor case, approx. 2.5'x4.5'
7	Pregnent of concrete, approx. 300 1b
8	Fragment of concrete, approx. 12 1b
9	Four marks of burned propellant
10	Two marks of burned propellant
n	Pregnent of motor case, approx. 4'x6'
15	Fragment of motor case, approx. h'xh'
13	Residue of burned propellant
14	Residue of burned propellant
15	Residue of burned propellant
16	Pragment of motor insulation, approx. 18"x15"
17	Pragment of motor insulation, approx. 16"c18"
19	Pragment of motor case, approx. 8'xh'
19	Fragment of motor insulation, approx. 18"x18"
20	Fragment of motor insulation, approx. 24"x18"
21	Prespect of concrete, approx. 50 15 41.
55	Fragment of concrete, approx. 500 16.
23	Fragment of motor, applica. 2'x4'

24	Line of residue from burned propellant
25	Realdor from burned propellant
26	Residue from burned propellant, approx. 5' dism.
27	Pragment of concrete, approx. 150 1b
28	Residue of burned propellant
59	Restine of burned propellant
30	Recidue of burned propellant
31	Fragment of concrete, approx. 200 1b
32	Realthe of burned propellant, approx. 10 ftam.
	·

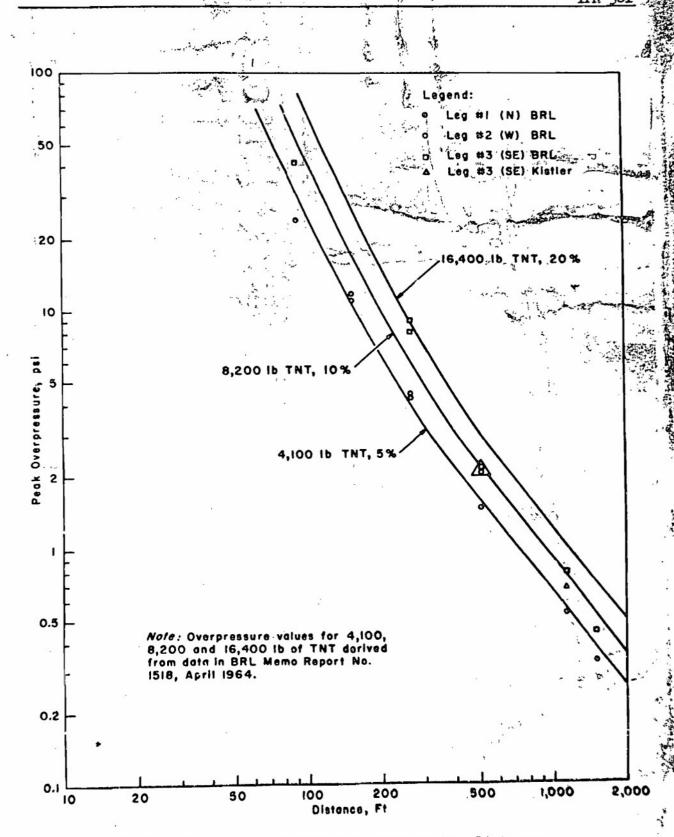
FIG. 21. Graph Showing Overpressure Vs. Distance.

Inspection of individual values for overpressure and impulse shows a tendency for gages close to the target on the southerst leg (#3) to run higher than corresponding gages on the west leg (#2). Gage records from the north leg (#1) ran lower than those from corresponding positions on the west and southeast legs. This is anticipated behavior since gages on the southeast leg near the target were expected to sense overpressure reinforcement resulting from target reflections, and gages on the north leg were sheltered from the full effect of the blast by the target mass.

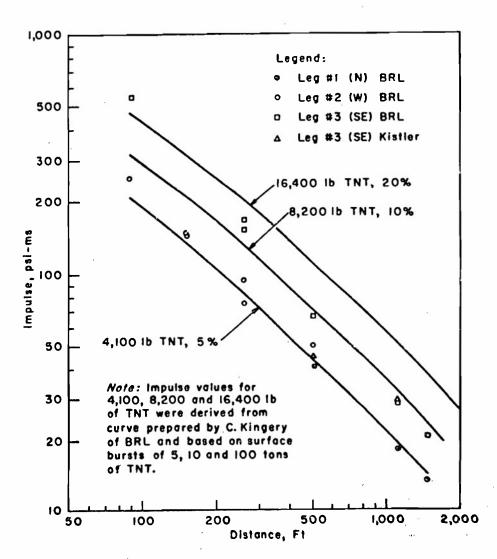
FIG. 22. Graph Showing Impulse Vs. Distance.

Yields based on impulse data were derived by interpolation between computed TNT weight versus impulse values which, in turn, were derived from the BRL curve used as the source of reference lines on Fig. 22.

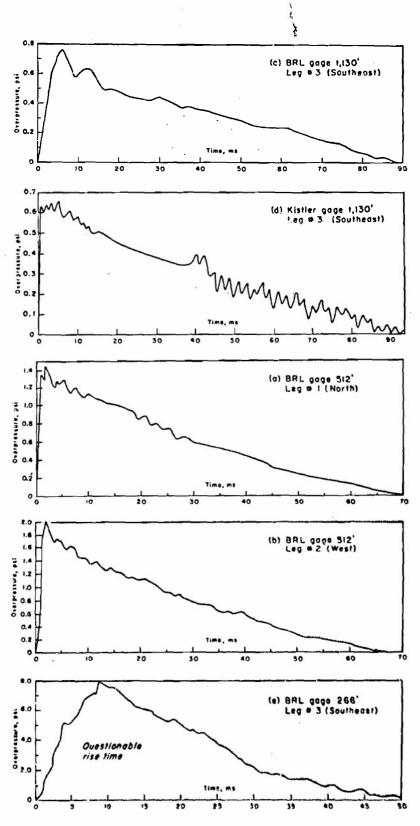
FIG. 23. Typical Blast Gage Records (Note Scale Variation).

In general, the recorded overpressure-time histories were classical in shape; however, a few BRL records exhibited an unusually long rise time to peak pressure. Figure 23 shows typical gage records, four of which are from BRL gages and one is from a Kistler gage. The Kistler gage record at 512 ft on the SE leg was less regular in shape and more difficult to interpret than the record of the Kistler gage at 1,130 ft on the same leg.
